# **INFRASTRUCTURE AUDIT**

Village of Bittern Lake

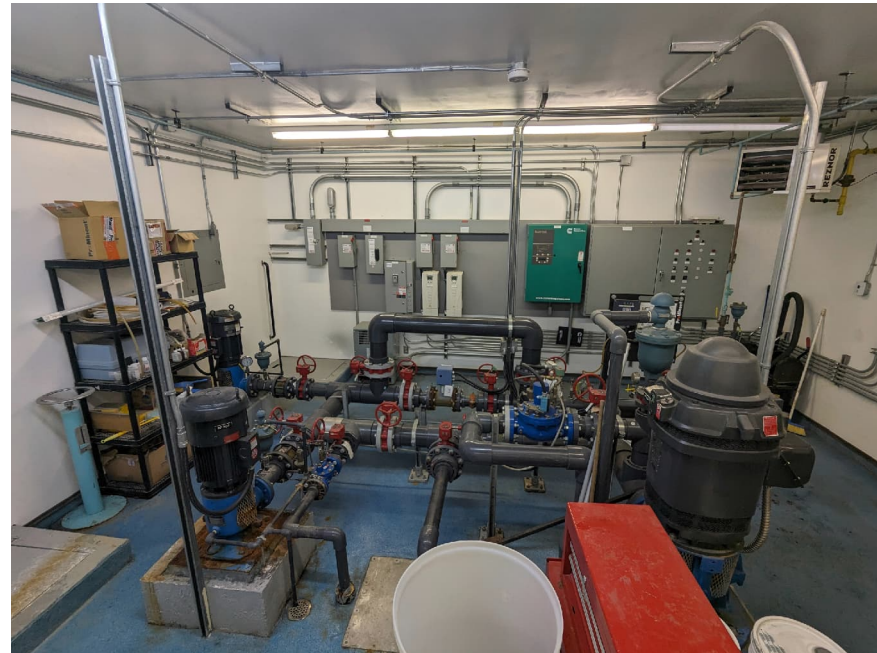
# Pump Station

- ❑ Adequate Condition Overall
- ❑ Continue Maintenance
- ❑ Implement SCADA

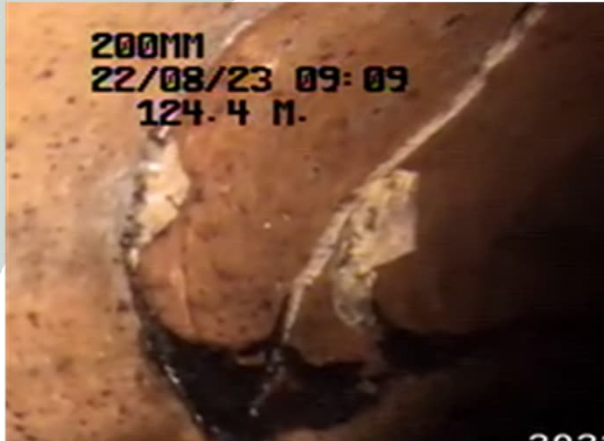
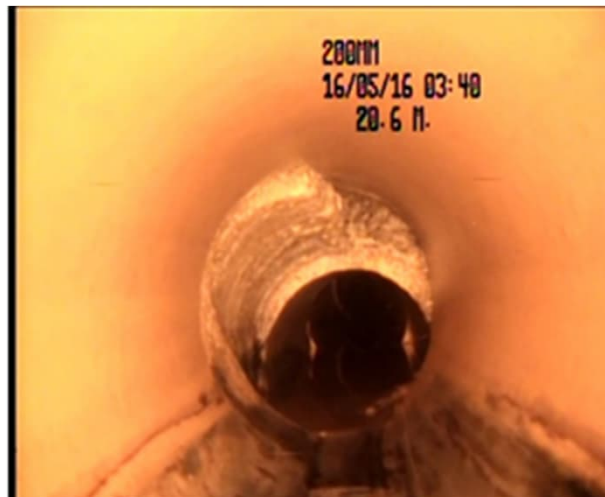
# Sanitary Main Camera Inspection

- ❑ Cracks
- ❑ Exposed Gaskets
- ❑ Breaks
- ❑ Joint offsets/ gaps
- ❑ Sags
- ❑ Intrusions
  - Services
  - Roots
  - Mineral deposits

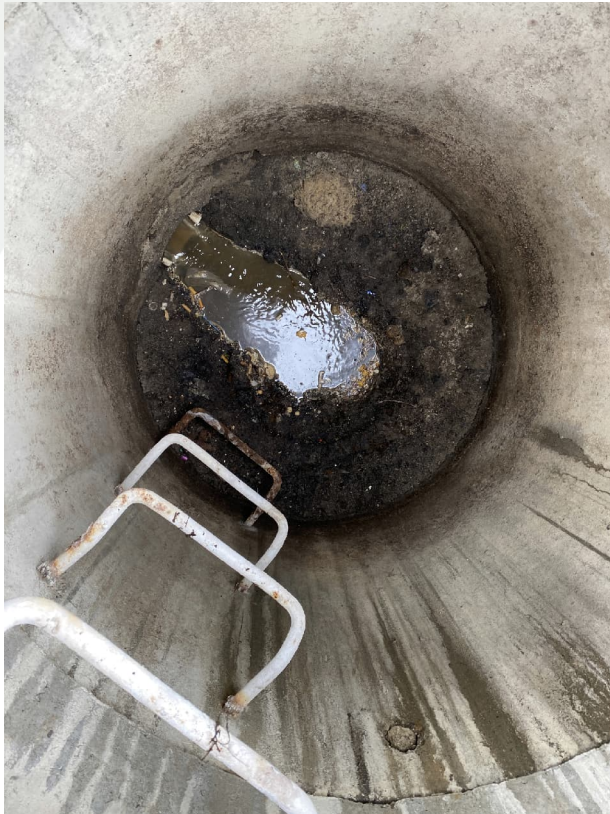
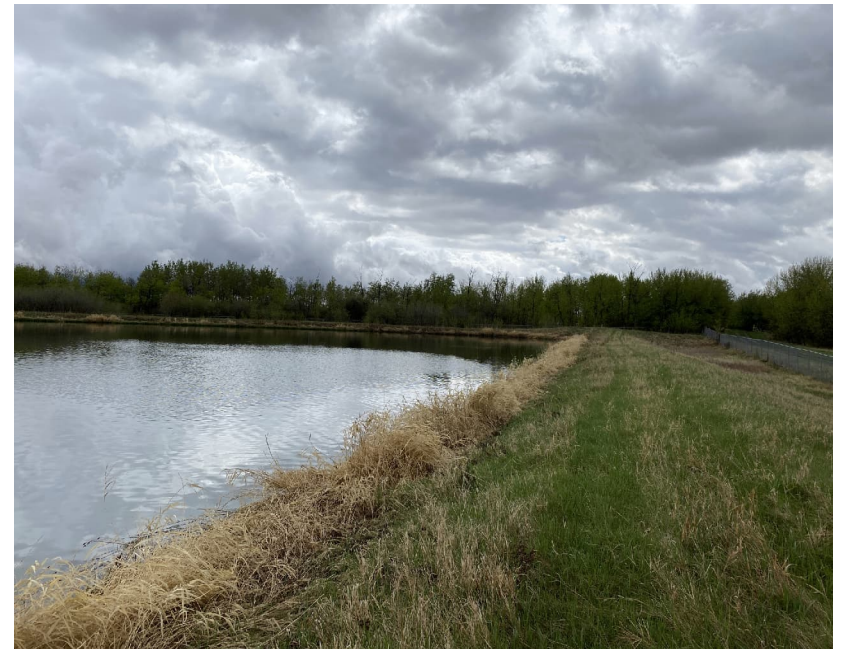
# Lagoon Condition

- ❑ Significant Vegetation Growth
- ❑ No Erosion
- ❑ Inlet Structure
- ❑ Fence Requires Repair

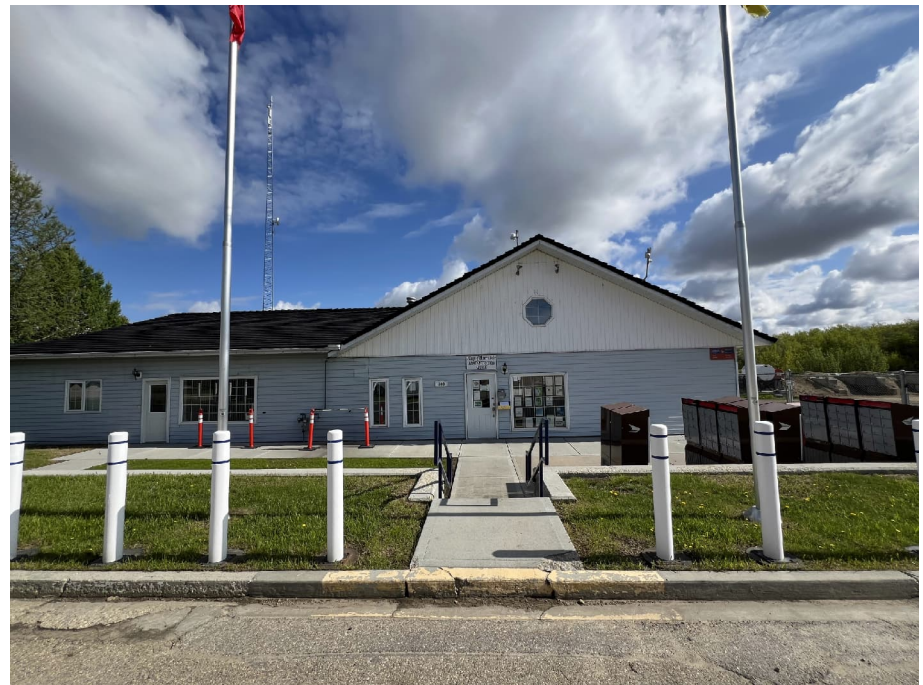
# Village Office

- ❑ Deficiencies:
  - Exterior Siding
  - Crack in the Foundation
  - Doors and Overhead Doors
  - Carpet
  - Furnace
  - Washroom Exhaust Fan
  - Condenser
  - Exit Sign Lighting
  - Light Fixtures

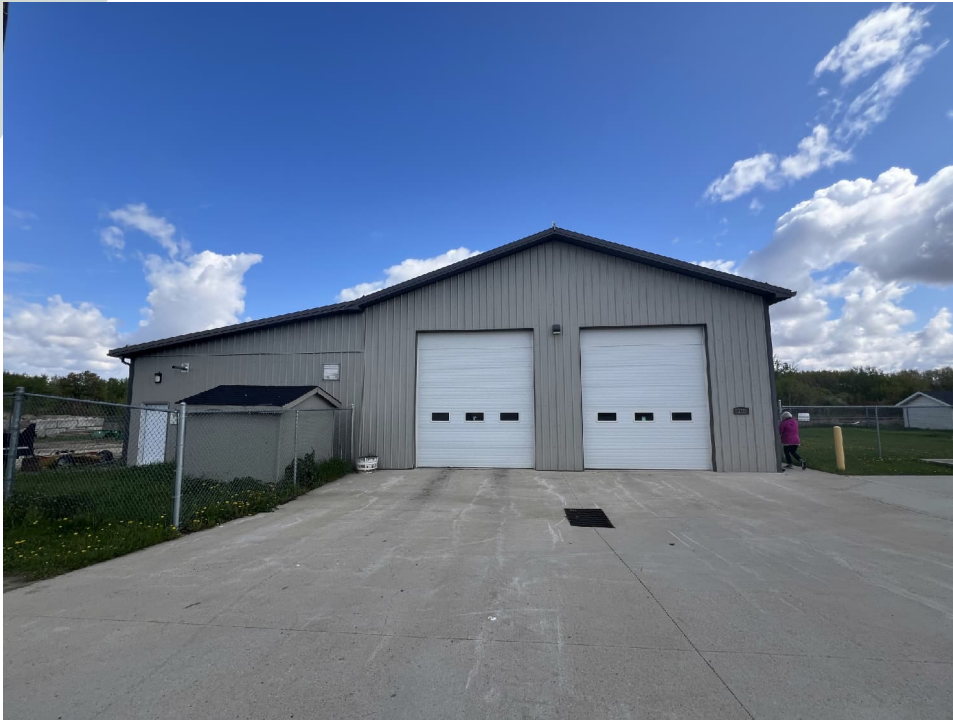
# Public Works Shop

- Deficiencies:
  - Mezzanine Column
  - Exhaust Switch

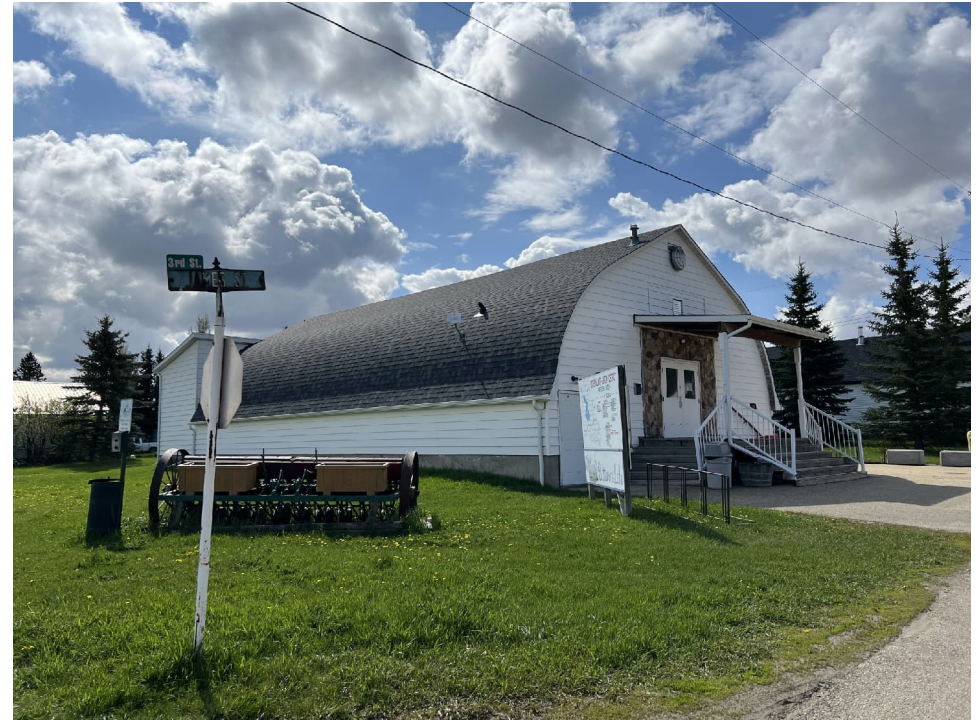
# Community Hall

- Deficiencies:
  - Railing Fasteners
  - Exterior Siding
  - Painted Surfaces
  - Possible Hazardous Materials
  - Furnace
  - Washroom Exhausts
  - Light Fixtures

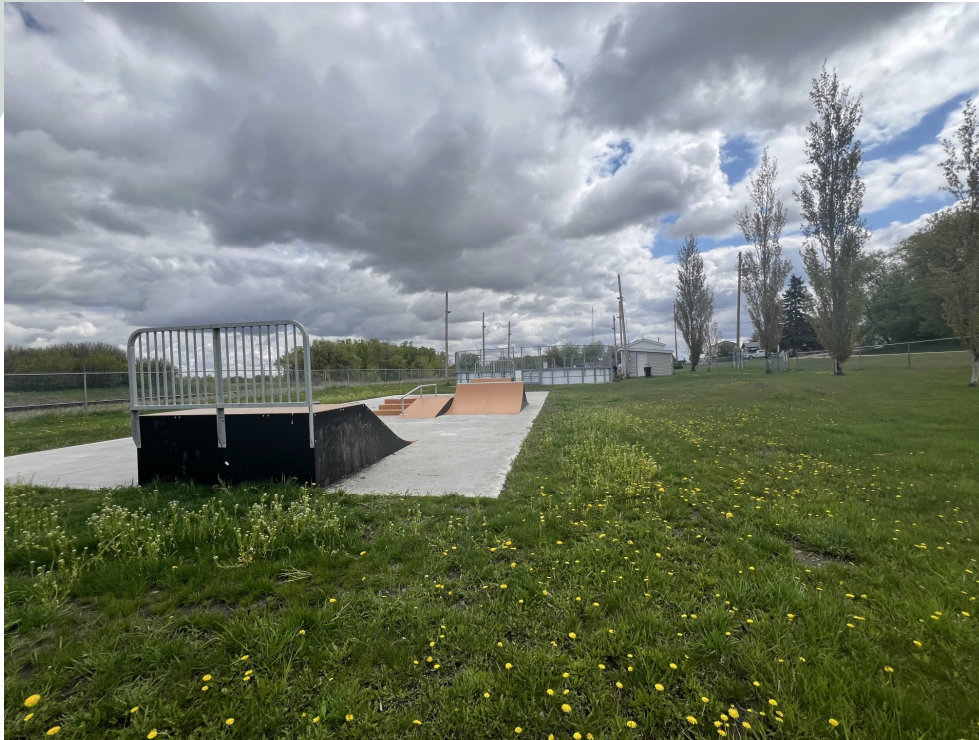
# Skate Park and Skating Rink

- Deficiencies:
  - Exterior Siding
