# **INFRASTRUCTURE AUDIT**

Village of Bittern Lake

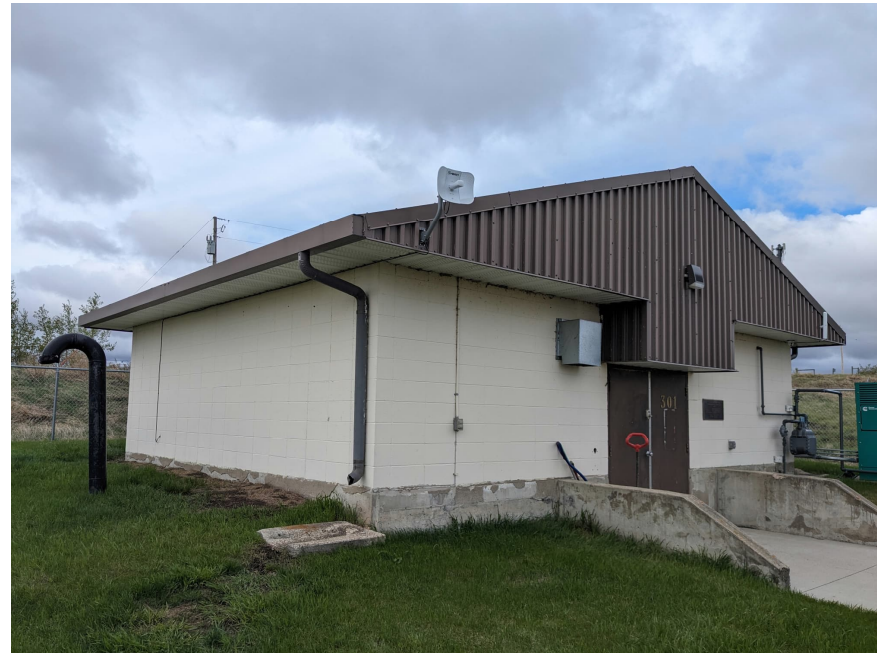
- ❑ City of Camrose
- ❑ Reservoir and Pump Station
- ❑ Reservoir Capacity = 550 m<sup>3</sup>
- ❑ Required Storage for Typical Consumption = 163 m<sup>3</sup>
- ❑ Storage recommended for Fire Demand = 540m<sup>3</sup>

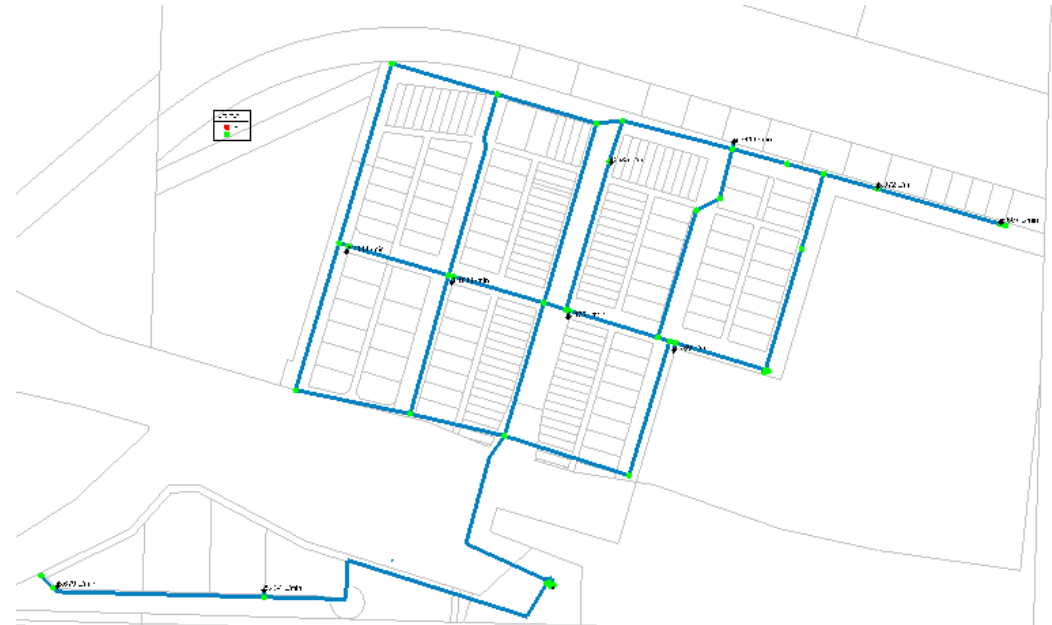
- ❑ System Layout
- ❑ Historical Water Demands
- ❑ Fire Flows
- ❑ Hydrant Testing
- ❑ Results
  - Adequate Pressure
  - Limited Fire Flow

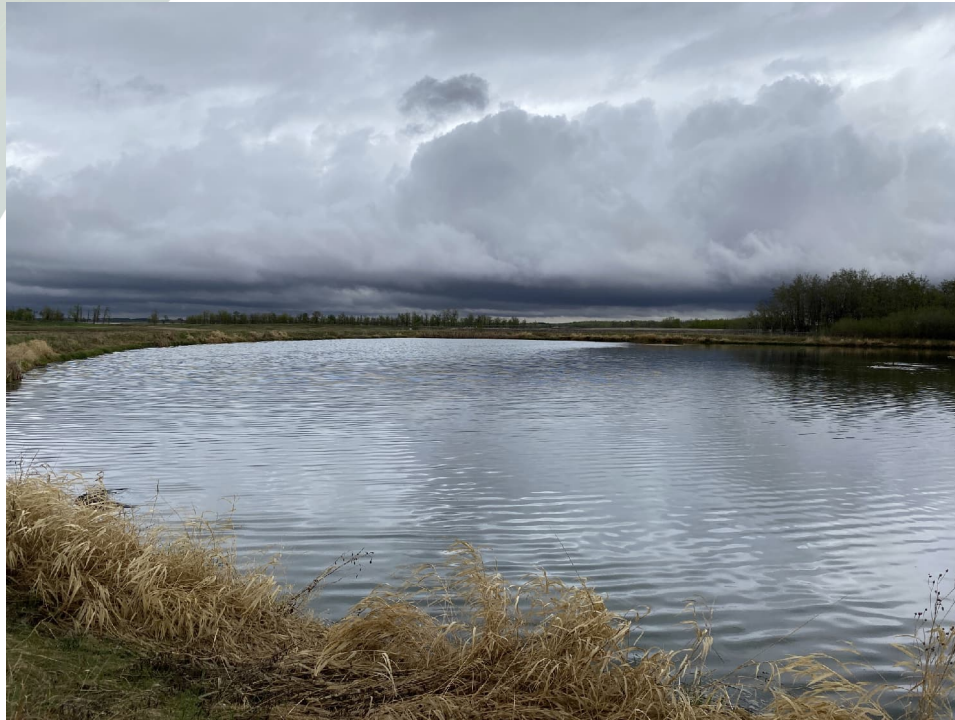
- ❑ Single Cell
- ❑ Capacity
- ❑ Configuration

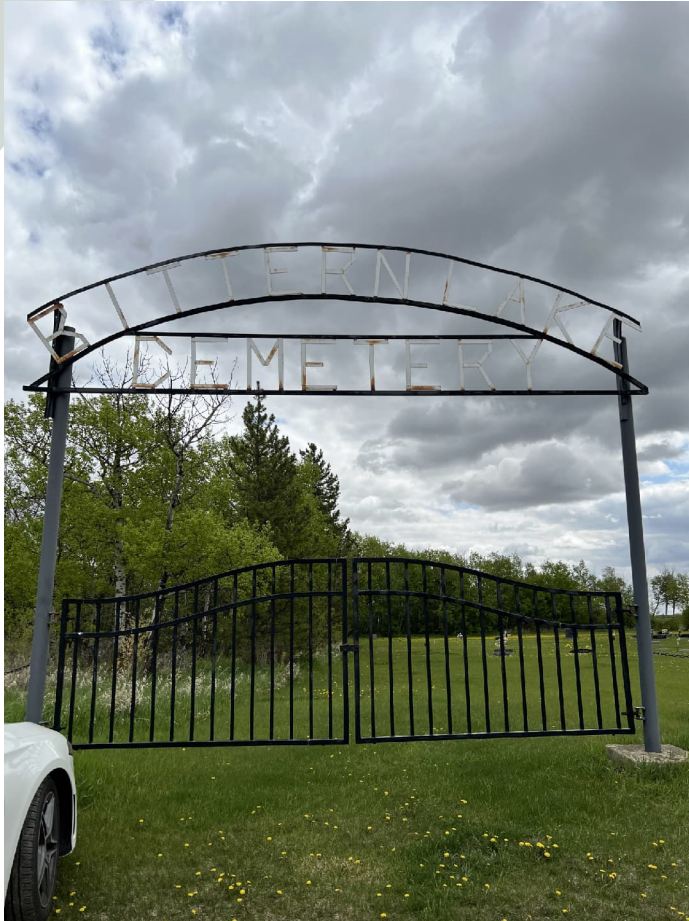
- Deficiencies:
  - None
